Manhole Inspection Summary

Manhole # S23M1_004MH

Insp Date: **1/21/09 10:08 AM**

Location Address: **3036 Stranden-Mallview**

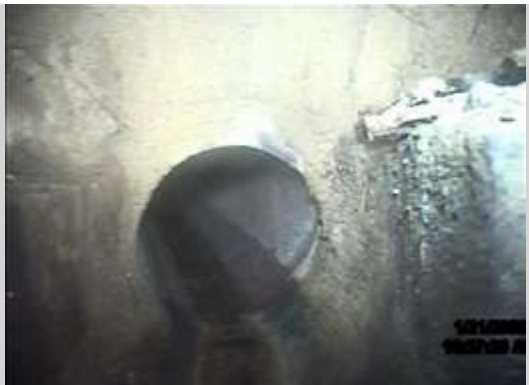
4 O'Clock Inflow

6 in. Circular Gravity Sewer
Pipe In @ 4 O'Clock

Pipe Height: **6** (in.) Rod and Bar (Angled)
Pipe Material: **Clay** ☐ Pipe Lined
Invert Depth: **11.44** (ft.) Flow Characteristics: **Slow**
Deposits: ☒ **None** ☐ Mud ☐ Sludge ☐ Debris ☐ Grease
Silt Depth: **0** (in.) Deposits Extent:
Infiltration: **None** Pipe Seal Cond: **Sound**

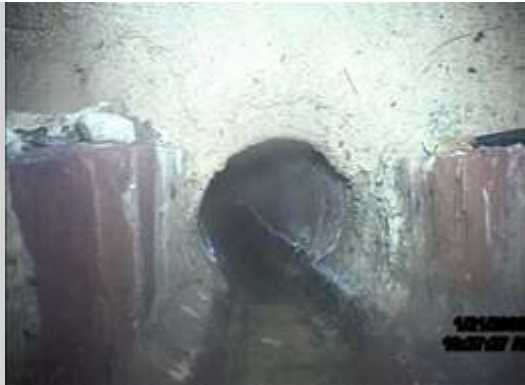
6 O'Clock Inflow

6 in. Circular Gravity Sewer

Pipe In @ 6 O'Clock

Pipe Height: **6** (in.) Rod and Bar (Angled)

Deposits: ☒ None ☐ Mud ☐ Sludge ☐ Debris ☐ Grease

Infiltration: **None**

Pipe Seal Cond: **Sound**

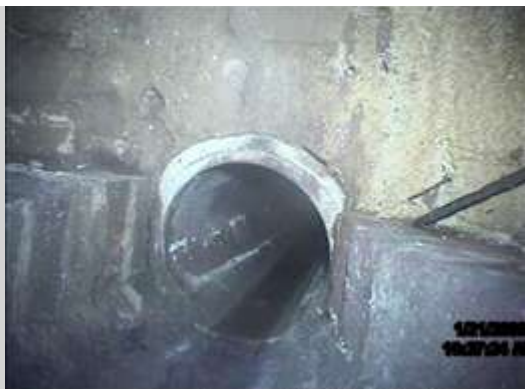
8 O'Clock Inflow

8 in. Circular Gravity Sewer

Pipe In @ 8 O'Clock

Pipe Height: **8.4** (in.) Rod and Bar (Angled)

Infiltration: **None**
